LITTLE YOUGHIOGHENY RIVER SITE NO. 7

NDI ID NO. MD 32

PHASE I INSPECTION REPORT

NATIONAL DAM INSPECTION PROGRAM

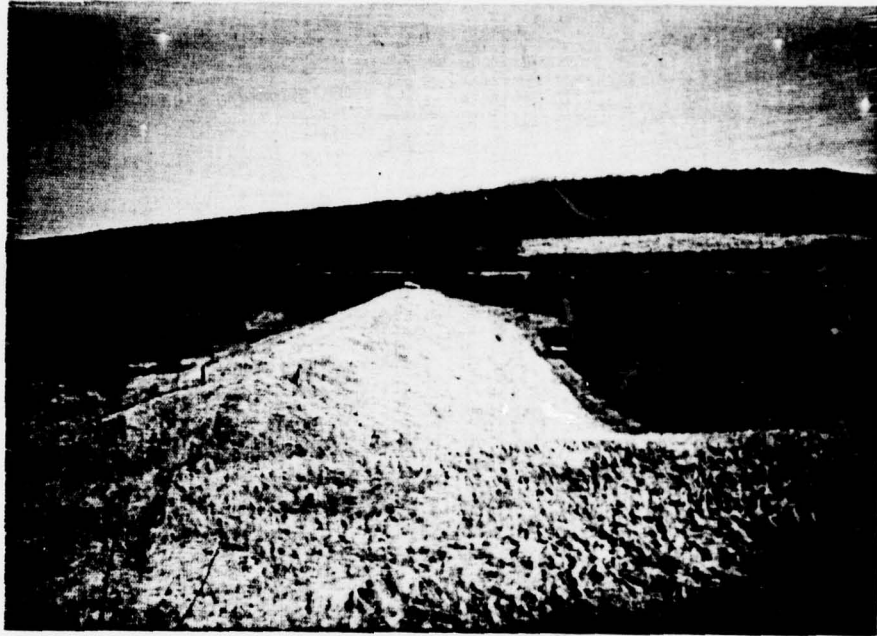
Overview of Dam

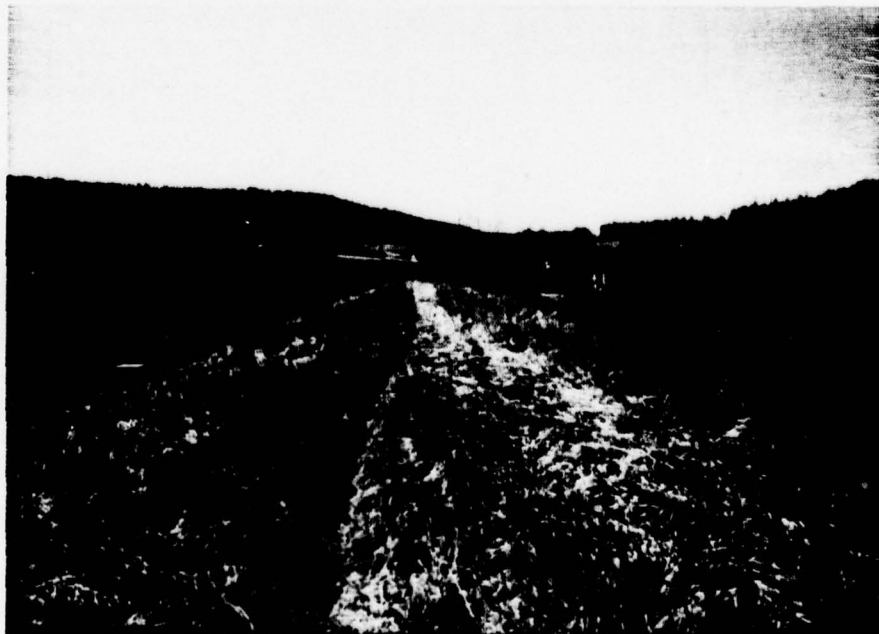
Overview of Dam Crest and
Emergency Spillway in Background

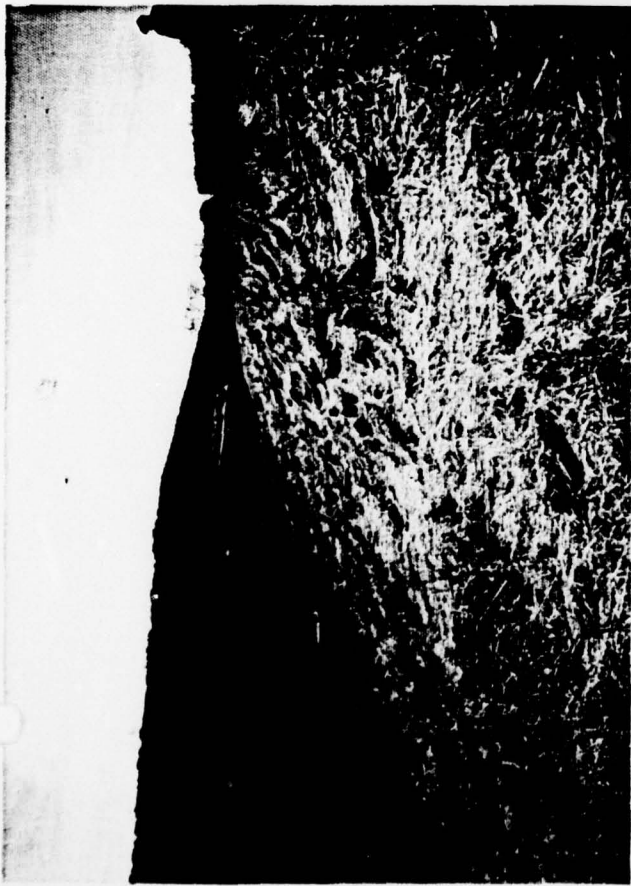
PHOTOGRAPH 1 View of upstream embankment slope and emergency spillway inlet in background.

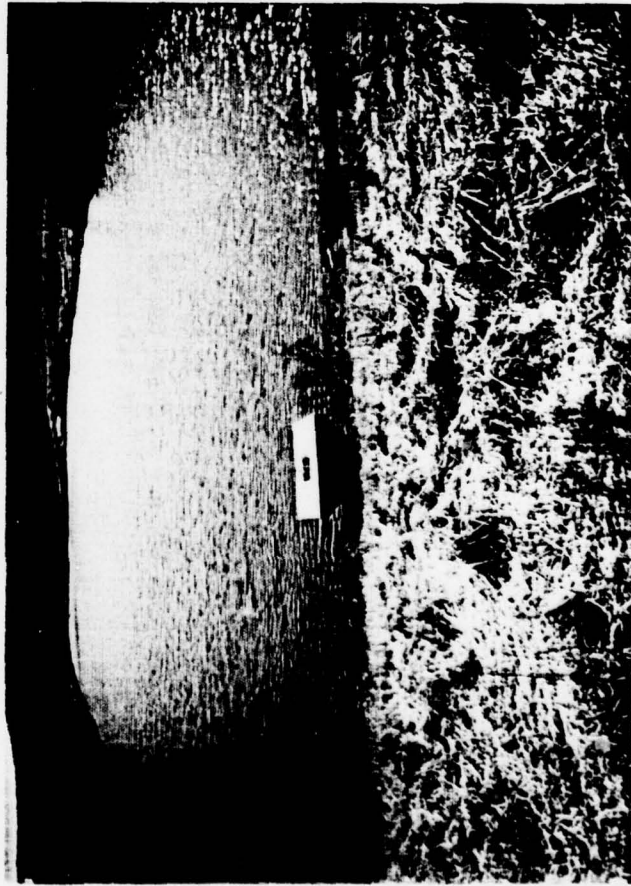
PHOTOGRAPH 3 Overview of principal spillway riser and reservoir.

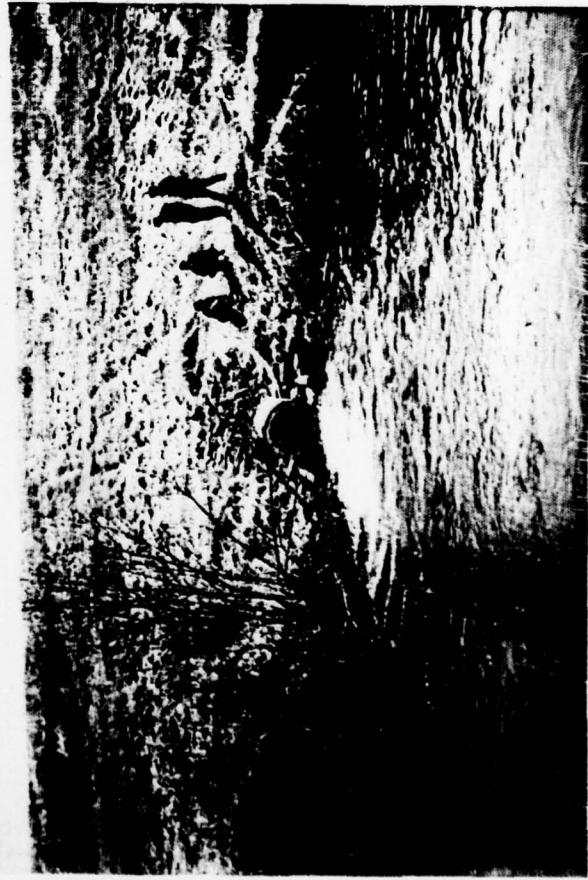
On the date of the field reconnaissance review, the outlet drain pipes were observed inundated by tailwater. The exposed bottom of the south outlet toe drain was observed rusted through. This outlet toe drain was reportedly accidentally damaged by Soil Conservation Service inspection personnel about two weeks later.

PHOTOGRAPH 7 View of seepage toe drains and outlet discharge pipe..

- 1) Remove deposited bank material obstructing downstream exit channel.
- 2) Remove damaged end section of the south seepage outlet drain pipe. Replace with new pipe end section, or install a perforated plastic pipe inside remaining outlet pipe sections.

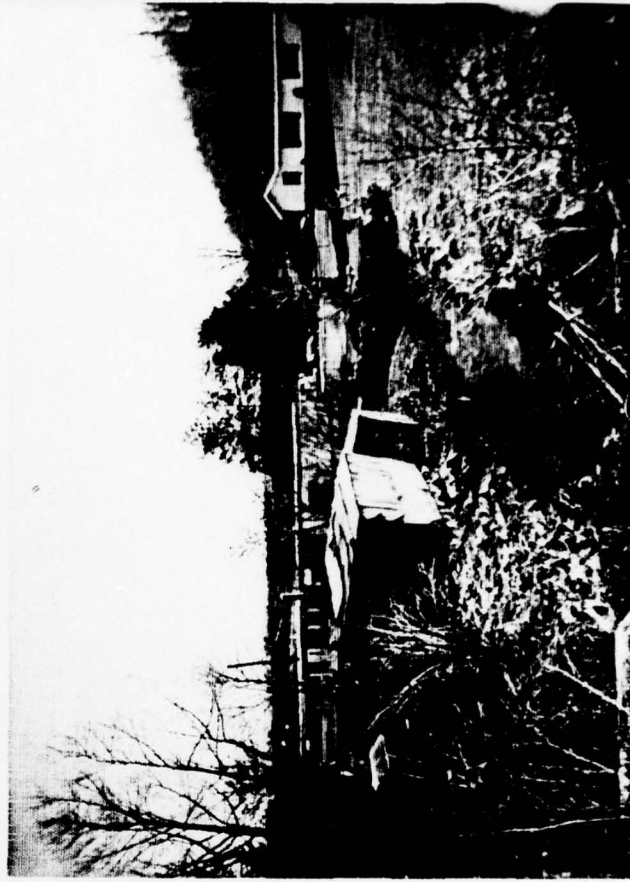
PHOTOGRAPH 8 View of homes located adjacent to downstream channel.
